Fresh Water Tank - Israel, Tel Aviv

Circular strengthening with CFRP-plates

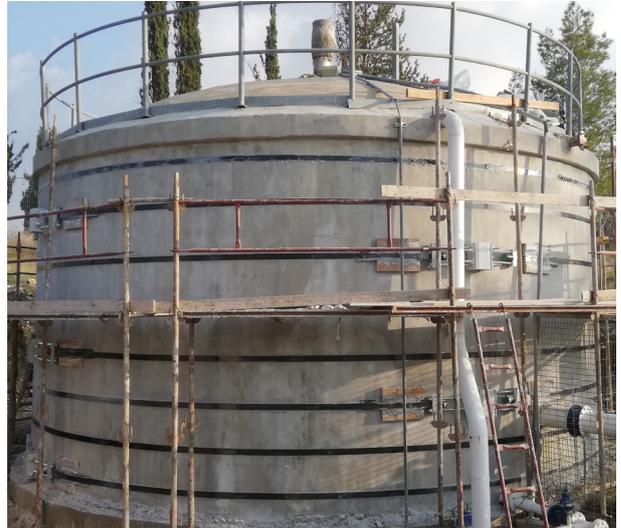
Due to the low dead weight of the tendons, no cranes or lifting equipment were required for the entire installation process of the CarboStress system. A simple scaffold was sufficient.

As static reinforcement, eight CarboStress systems were installed, each with 180kN tension force distributed over the height. In order to keep friction losses low during the tensioning process, the CarboStress systems were tensioned synchronously on both sides and the areas of the end anchorages were staggered around the tank.

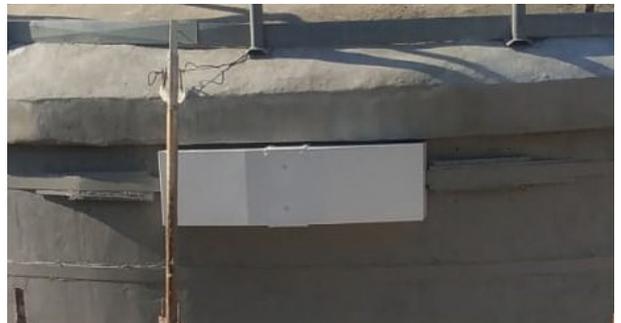
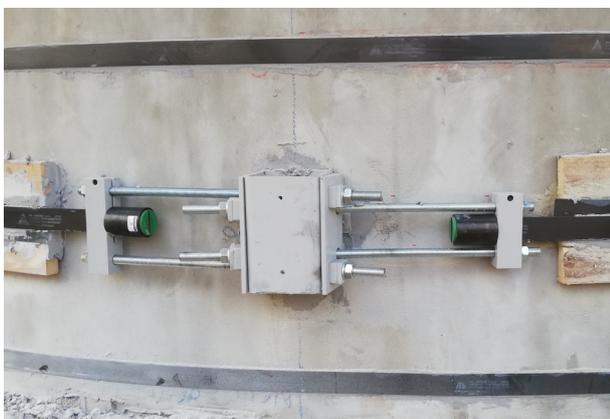
The anchorage areas are protected against heat and external impact by means of a steel cover. In addition, the fresh water tank and the CarboStress tendons are painted white.
